REMOVAL ACTION PLAN
DAYTON TIRE AND RUBBER COMPANY
DAYTON, OHIO

CONTRACT NO. 68-01-7367

WESTON-SPER
Technical Assistance Team
Region V

January 1988

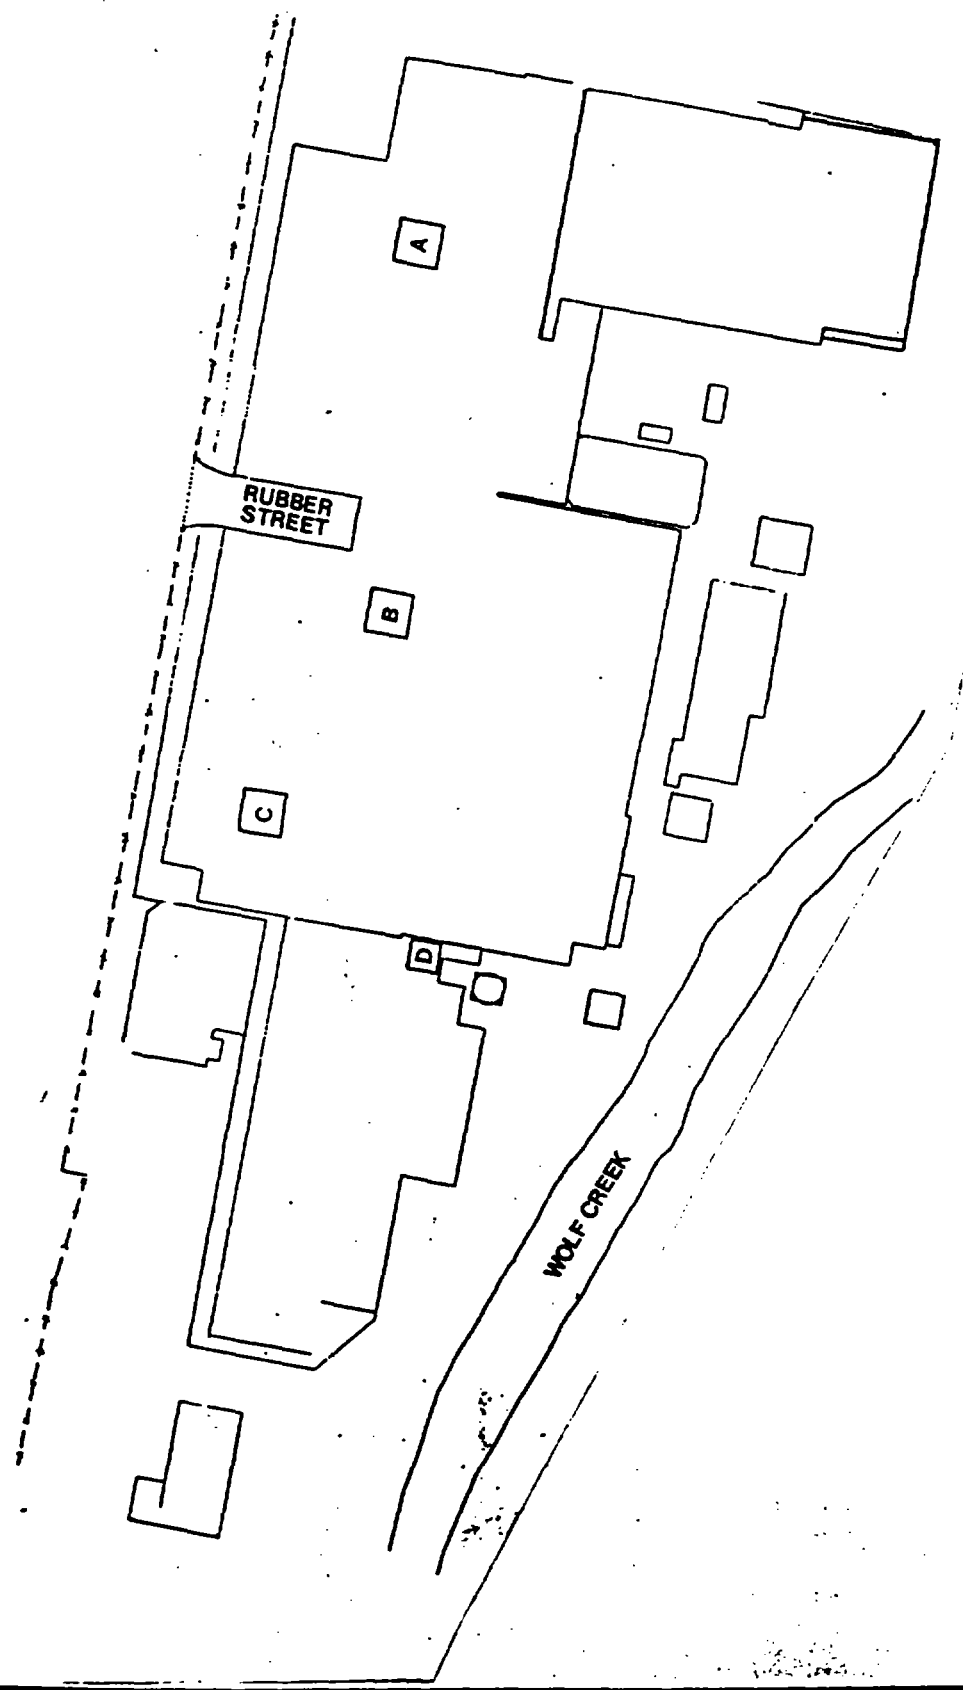
FIGURE 4
ROOF PLAN
DAYTON TIRE AND RUBBER COMPANY
DAYTON, OHIO

Three roof-top transformer stations, containing 11 transformers, remained on the multi-level facility. Transformer station C (Figure 4), located on the western end of the roof area, had been salvaged. Three of the five transformers were found lying on their sides with the copper metal from their interior removed, and scrap metal bands discarded nearby. The oil from these transformers had been released as indicated by the dark stains surrounding the transformer carcasses. The remaining roof transformer stations, A and B, appeared to have been left intact, although some of the transformers were empty and the surrounding concrete dikes contained oily substances.
